## **TEST REPORT**

Stage Luminaire

XP-550 BEAM IP, XP-550 BSW IP

IEC 60598-1:2014+A1:2017

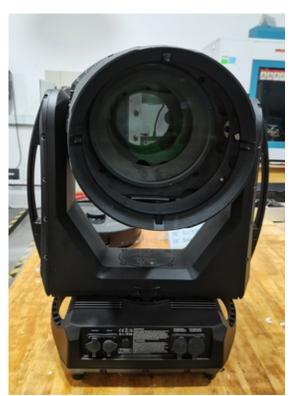
Photo 1 Before the test sample

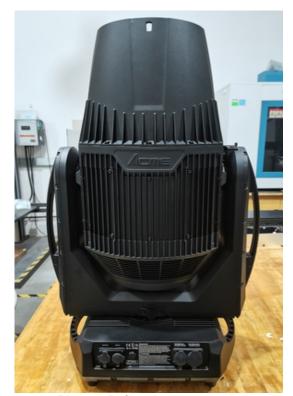
Photo 2 Before the test sample
